FIRE CHIEFS
investigate, demonstrate and
SPEAK OUT
ON FIRE SAFETY.

OPERATION SAN FRANCISCO

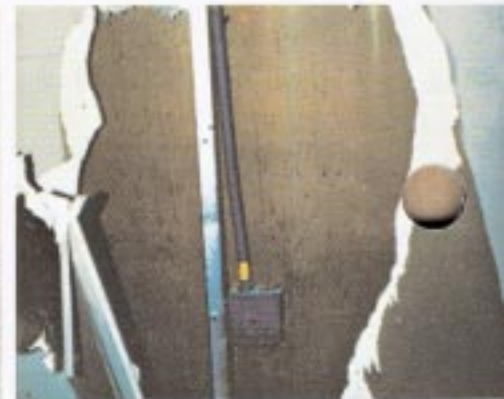
① This wall receptacle in the apartment master bedroom shows the extent of fire damage to bed frame, wall and outlet plate, while circuit operation is demonstrated by light. Recorded room temperatures are shown in Graph A. See Diagram II.

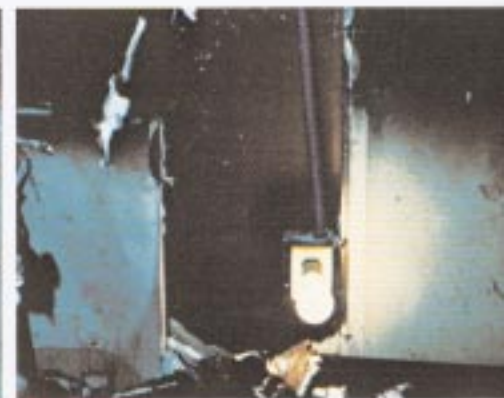
⑥ This receptacle is located in room 206 and is operative after flashover. Room temperatures during flashover shown in Graph B. See Diagram II.

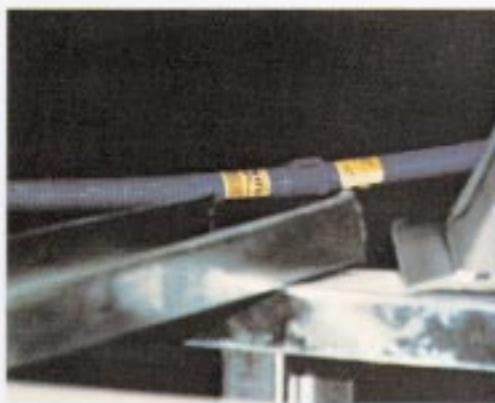
3 Electrical nonmetallic tubing running across ceiling of apartment master bedroom showing effects of fire but tubing intact. See Diagram II.

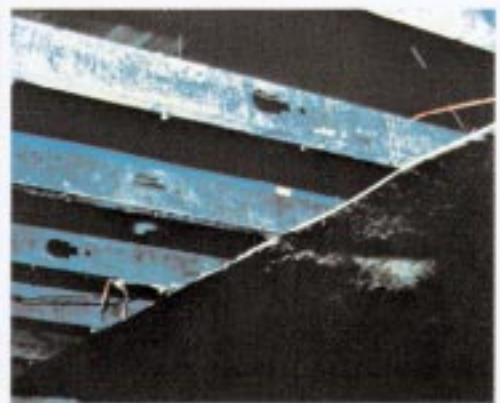
4 ENT™ running above apartment bedroom showing coupling for tubing. See Diagram II.

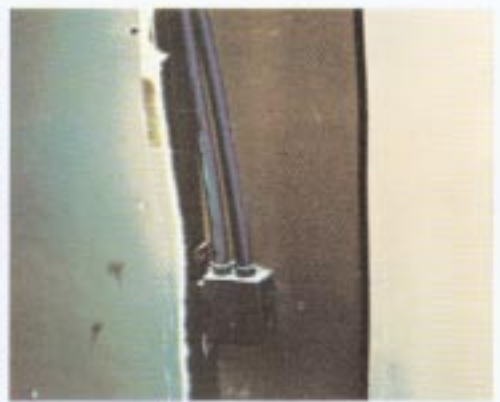
9 Outlet box in Blue Ballroom still functioning after final room burn (flashover). Temperatures are recorded in Graph C. See Diagram I.
