TRIAL BY FIRE

When fire breaks out every second counts. Recent fire tests, conducted by an independent testing laboratory, show that Electrical Non-metallic Tubing (ENT) and PVC Conduit protect electrical circuits longer than Electrical Metallic Tubing (EMT) and Intermediate Metallic (IMC) Conduit.

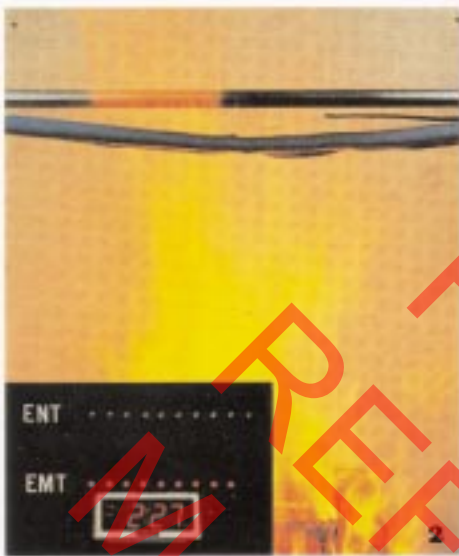
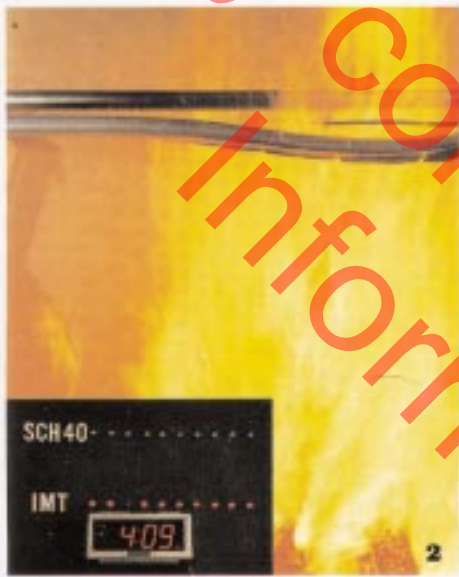
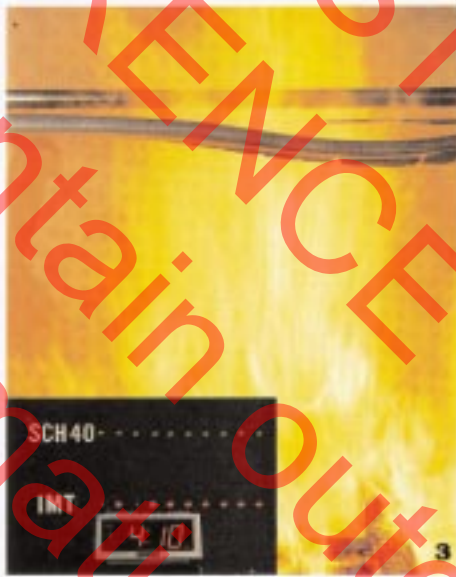
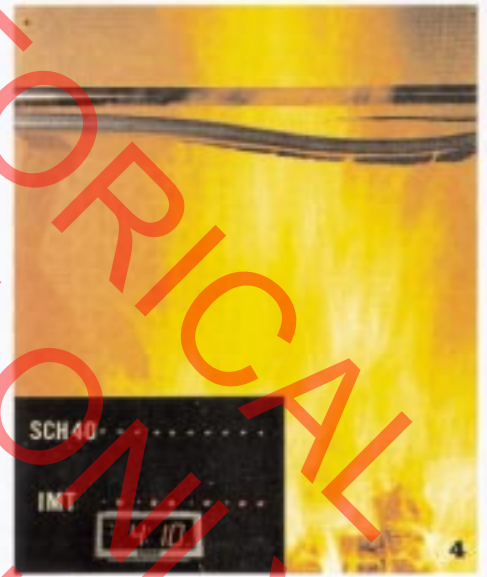
Test No. 1—Continued on Pg. 5

As shown by panel 1, all 10 circuits (green indicator lights) in the ENT conduit, and all 10 circuits (red indicator lights) in the EMT conduit were functional at the beginning of the test at 2:24. Panel 2 shows the first circuit failure in the EMT conduit at 2:27 three minutes into the test. Two additional EMT circuit failures followed rapidly (see panel 3).

At 2:28, four minutes into the test, all 10 circuits in the EMT had failed (panels 4 & 5). **Significantly, not a single circuit in the ENT conduit had failed at this time.**

At 2:29 (panel 6) the first circuit in the ENT conduit failed. At 2:30 (panel 7) all the remaining circuit indicator lights monitoring circuit integrity in the ENT conduit extinguished.

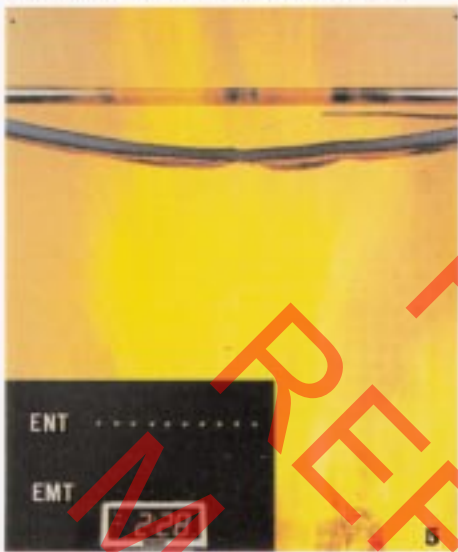
Test No. 1—Continued from Pg. 4

NOTE: The remaining circuits in the ENT conduit went dark simultaneously indicating a main fuse failure.

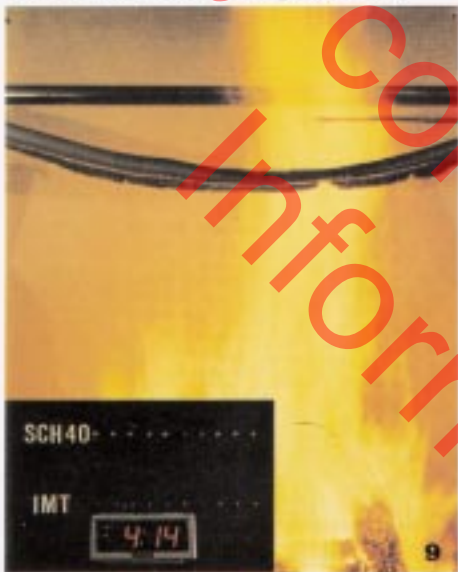
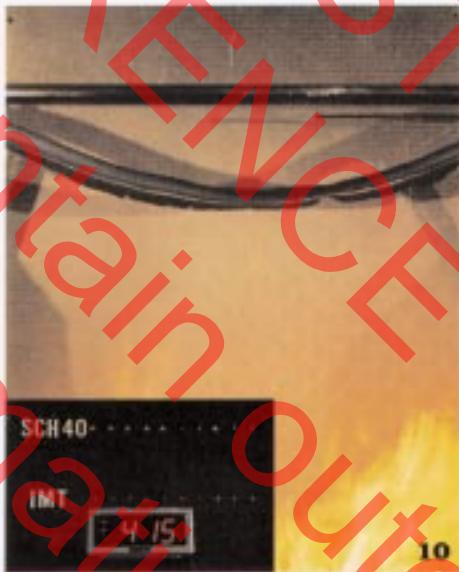
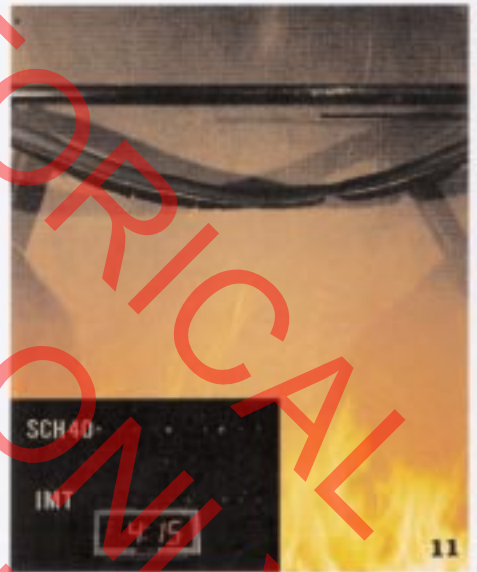
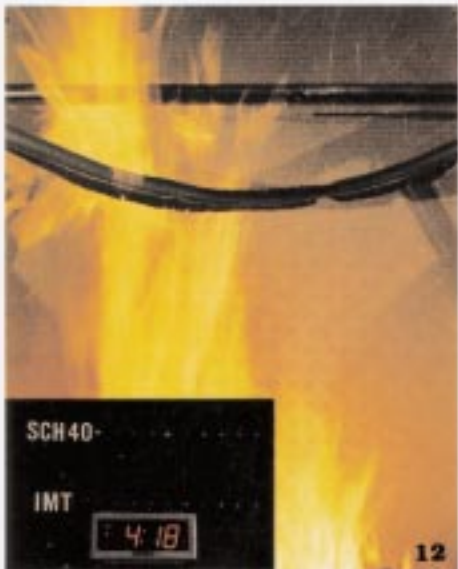
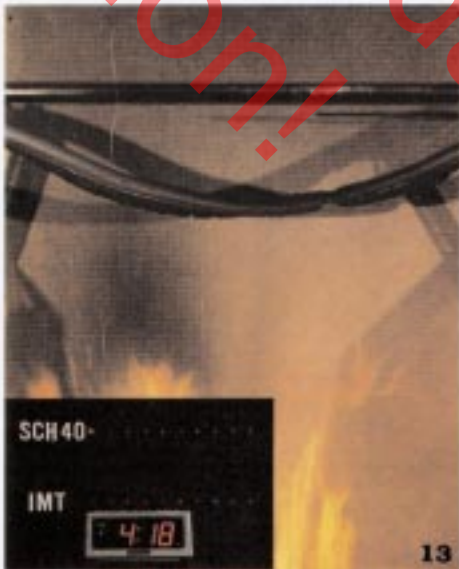
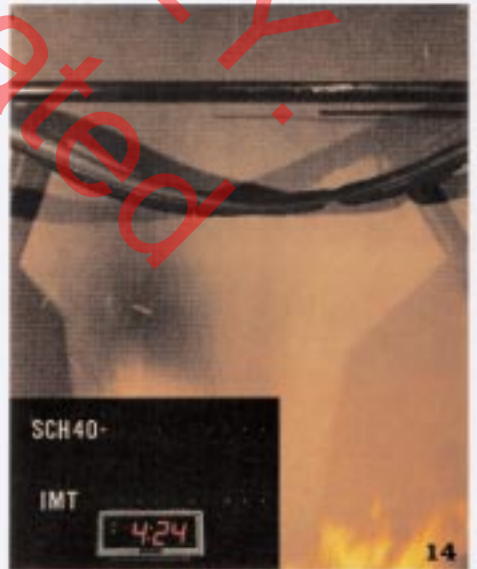
Test No. 2—Continued from Pg. 4

As shown by panel 2, at 4:09, 2 minutes into the test the first circuit failed in the IMC conduit. The second circuit in the IMC conduit failed at 4:10 (see panel 3) followed by two additional circuit failures in the third minute of the test (see panel 4). At 4:11 (see panels 5, 6, and 7) the remaining circuits in the IMC conduit failed. **Significantly, not a single circuit in the schedule 40 PVC conduit had failed up to that point.**

At 4:14, seven minutes into the test, the first circuit in the schedule 40 PVC failed, quickly followed by a second circuit failure (panel 9), followed by five circuit failures at 4:15 (panels 10 and 11). Two of the remaining three circuits in the schedule 40 PVC failed at 4:18 (see panels 12 and 13). The last remaining circuit in the schedule 40 PVC conduit (panel 14) remained illuminated when the test was terminated at 4:24.
