FIRE CHIEFS
investigate, demonstrate and
SPEAK OUT
ON FIRE SAFETY.

OPERATION SAN FRANCISCO

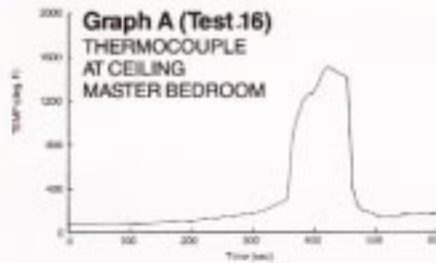
① This wall receptacle in the apartment master bedroom shows the extent of fire damage to bed frame, wall and outlet plate, while circuit operation is demonstrated by light. Recorded room temperatures are shown in Graph A. See Diagram II.
